RESEARCH HIGHLIGHT

Technical Series 05-120

INVESTIGATING MOISTURE IN SEASONAL HOUSING

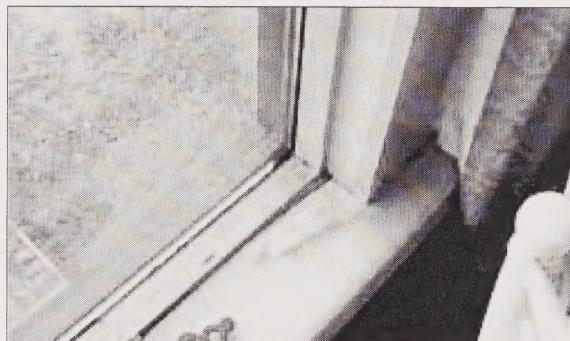
Interior: water damage at window sill
